# Manhole Inspection Summary

Manhole # S07II2003MH

Insp Date: **10/6/08 11:17 AM**

**Location** Address: **6313 PIMILICO RD**

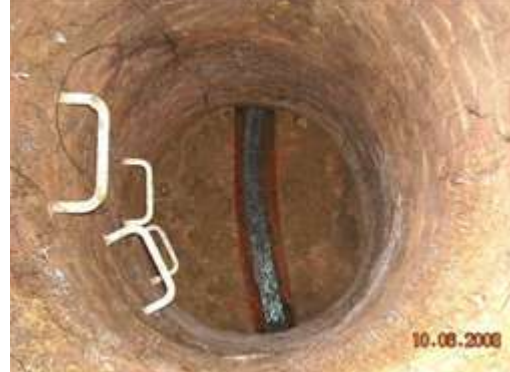
Top View

Adjustment, Corbel and Barrel root intrusion and infiltration. Evidence of surcharge - Bench debris.

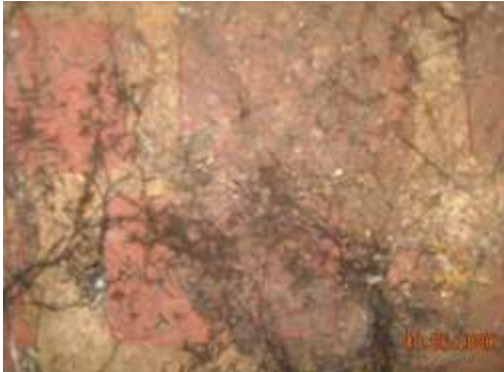
Defect

Barrel root intrusion and infiltration.

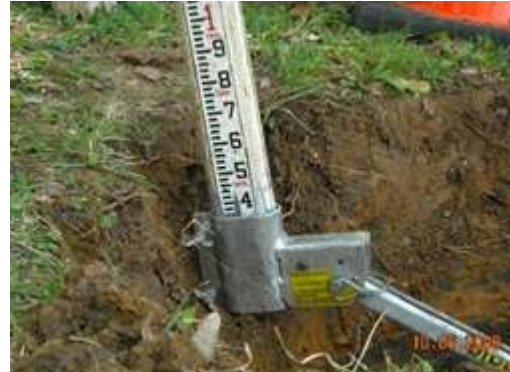
Defect

Below grade.

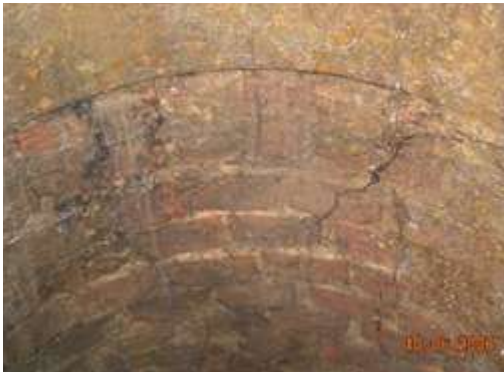
Defect

Adjustment and Corbel root intrusion and infiltration.

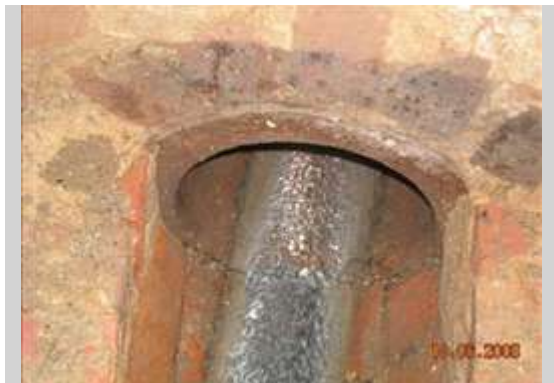
Pipe Out @ 12 O'Clock

Invert Depth: **9.35** (ft.) Flow Characteristics: **Slow**

Infiltration: **None** Pipe Seal Cond: **Unknown**

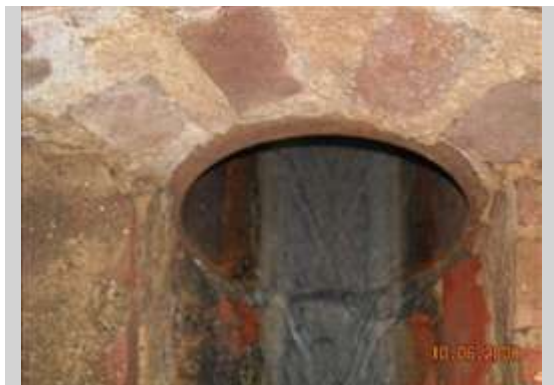
Pipe In @ 5 O'Clock

Invert Depth: **9.15** (ft.) Flow Characteristics: **Slow**

Infiltration: **None** Pipe Seal Cond: **Unknown**
